# Midsummer Common Conservation Plan 2001

#### *December 2003*

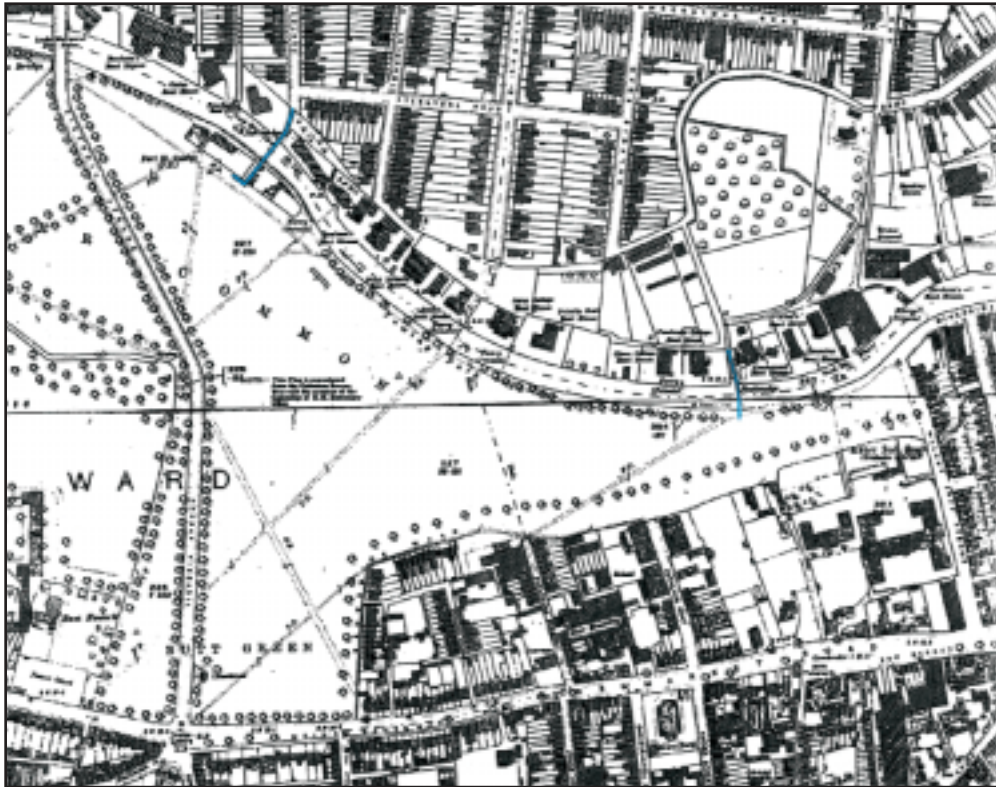
**1951 ORDNANCE SURVEY**

**Significant Additions**

- Fort St George and Pye footbridges constructed over the Cam (1927).

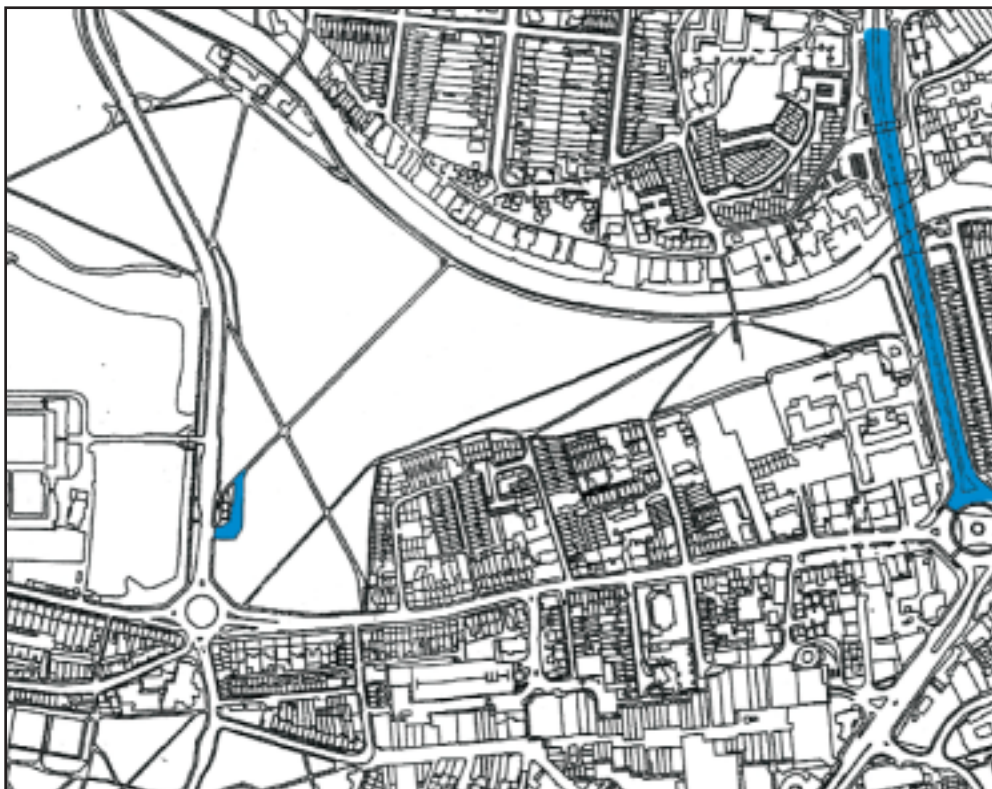
**2000 ORDNANCE SURVEY****Significant Additions**

- Elizabeth Way Bridge constructed (1971).
- Hard surfaced vehicle entrance to the common next to the public lavatories.

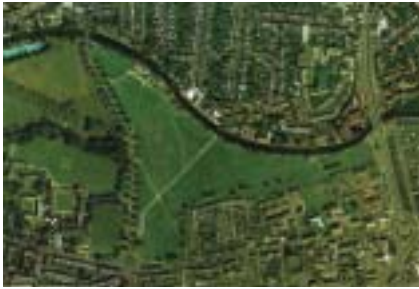
The common is an open grass area framed by sparse perimeter tree planting and its urban surroundings. Asphalt paths cross it in an unobtrusive way. Lighting is almost entirely restricted to the edges, with a few single lamp standards at path intersections.

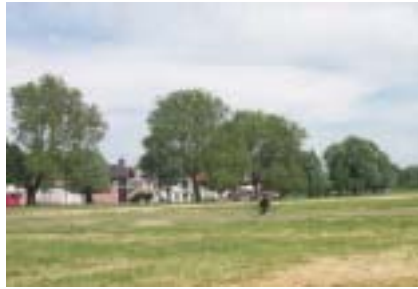
Boathouses enclose the view on the north side of the river along with visually very important willow, poplar and plane trees. Some of these are over mature or have large wind damage wounds.

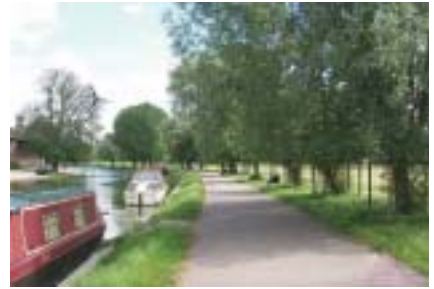
Rowing, holiday boats and angling create activity on the river and its attractive setting make the tow-path a pleasant place to sit. The common is accessible to a large area of housing north of the river via the footbridges. The footpaths are heavily used routes between there and the city centre.

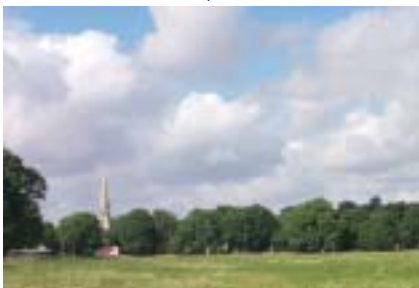
The horsechestnut avenue encloses the western boundary of the common, and is reinforced by the Jesus College tree planting behind. The spire of All Saints Church Jesus Lane is a distant focal point. Important views of Jesus Green from Victoria Avenue beneath the canopies of the trees maintain the connection between the two spaces.

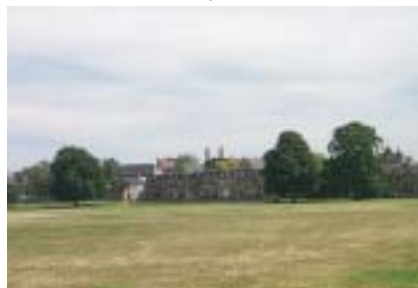
Sparse tree planting on the south side inadequately buffers the view between the common and the urban edge. The Listed Buildings of Brunswick Walk and North Terrace provide a high quality boundary. An important relationship exists between the common and the residential properties that overlook it. There are also valuable views of the common from the ends of the adjacent streets.

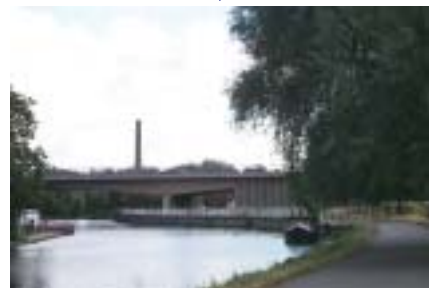
Trees growing in the Cambridge Regional College grounds are very important components of the view towards the east end of the common. The mass of the Elizabeth Way Bridge completely contains this eastern end, although there are views of the Old Pumping Station Chimney, now the Museum of Technology.

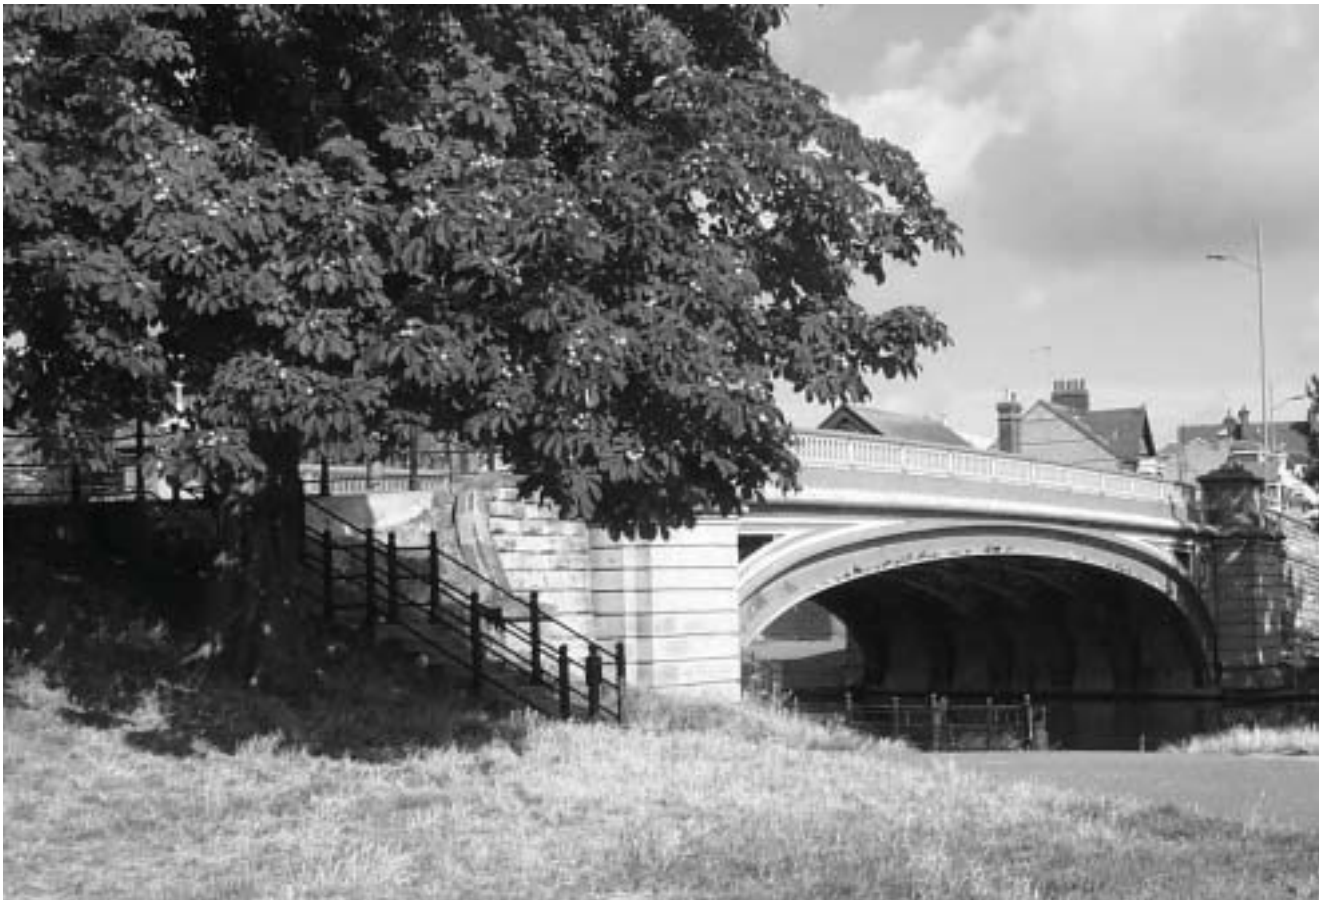
### 1. VICTORIA BRIDGE

This is a single span cast-iron bridge on stone abutments and approaches, with an elliptical arch and open iron balustrade. It is decorated on either side of the pierced spandrels with arms of the City and the University. The foundation stone was laid in 1889.

Continue to emphasise the ornamental nature of the bridge with a decorative colour scheme.

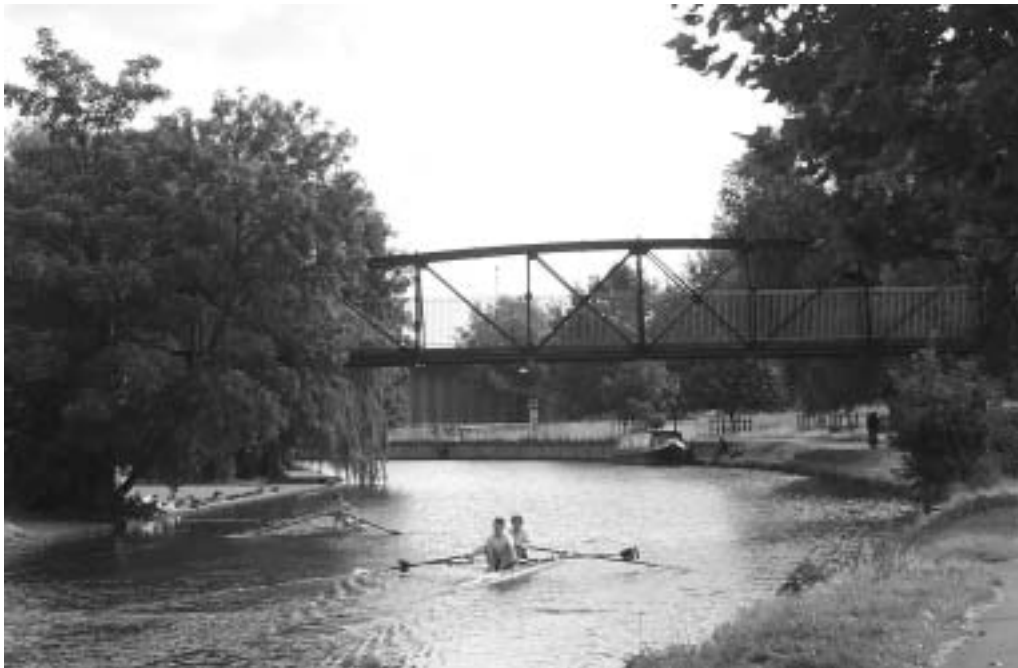
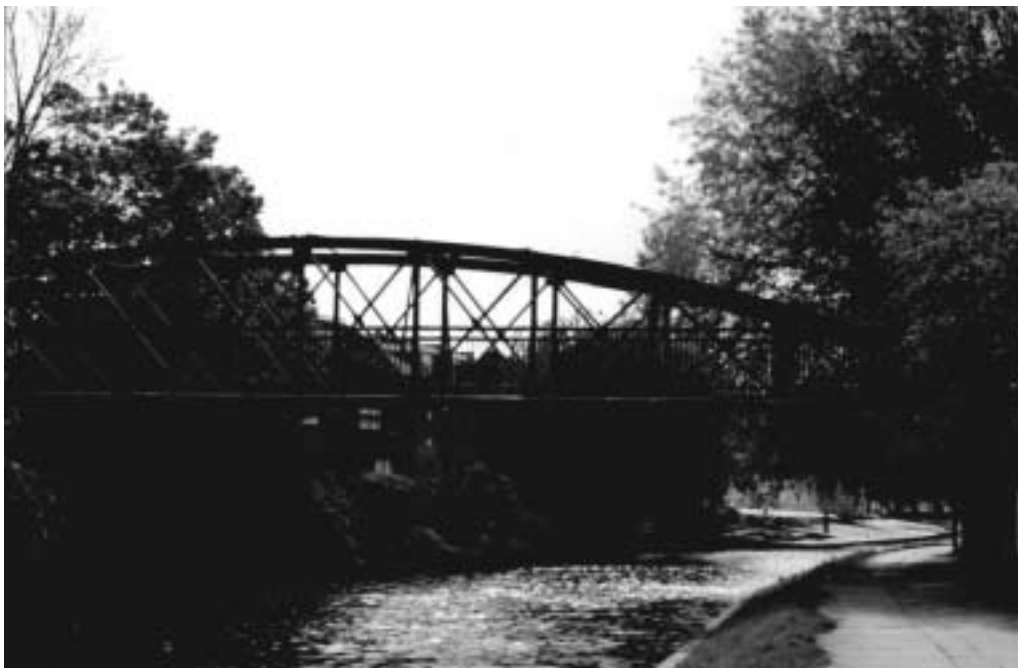
### 3. FOOTBRIDGES

The footbridges were built in 1927 to replace ferries across the river. They are owned and maintained by the County Council. The bridges themselves are simple, graceful structures although the ramps leading to them could be integrated better into the surroundings.

The ramp to the Pye bridge could be made less conspicuous by planting some trees or shrubs near, but not necessarily against it.

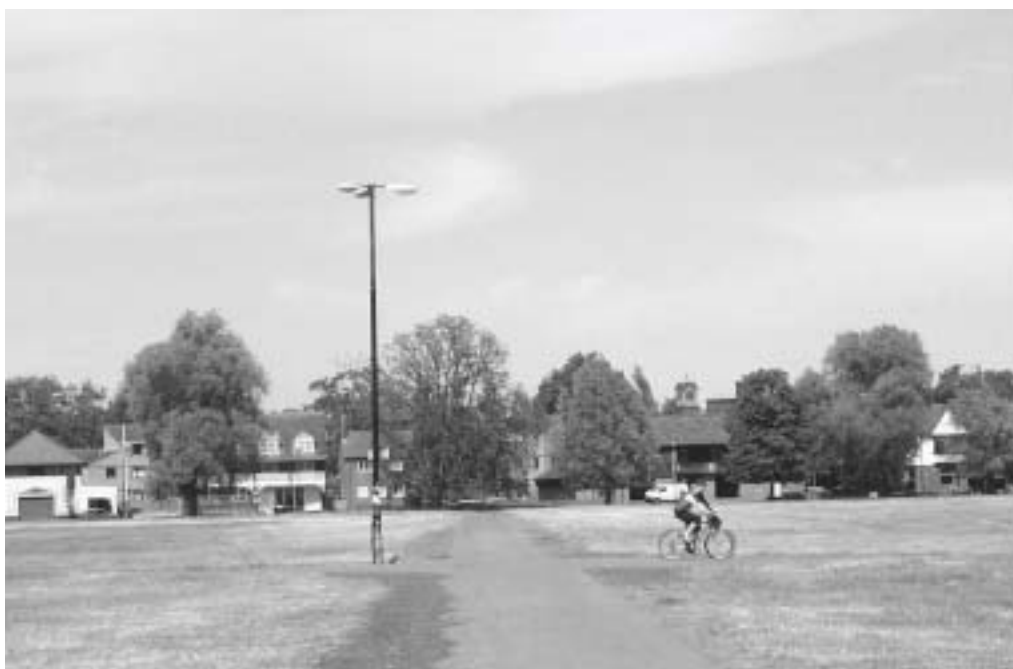
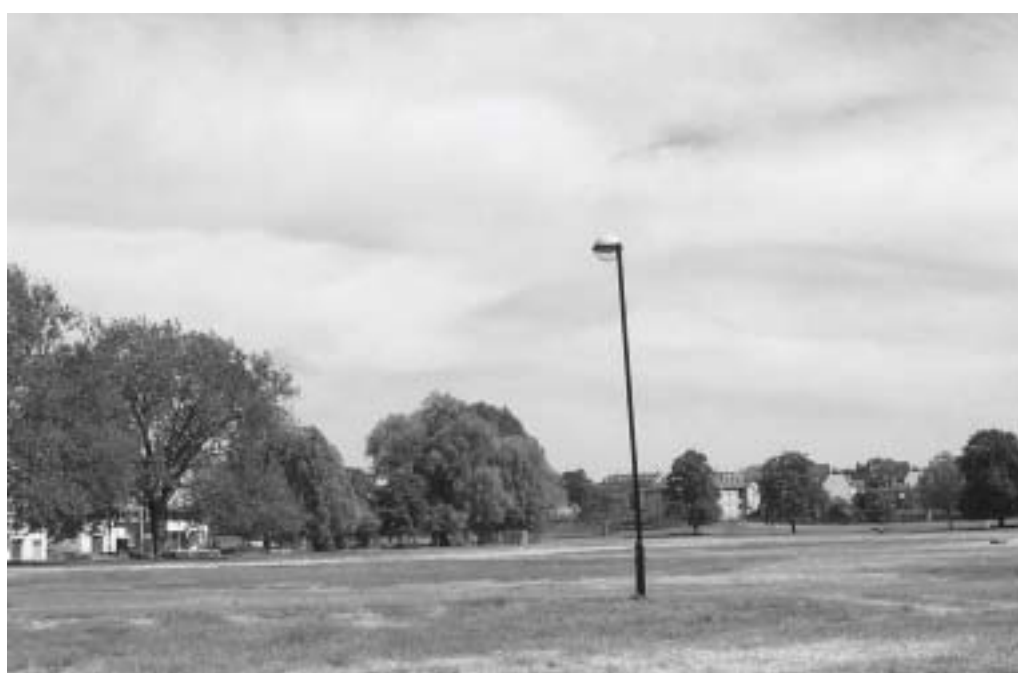
#### 4. LIGHTS

The lights along the riverside path are a modern globe design that fits fairly unobtrusively into the surroundings. The single lamp standards that illuminate the path intersections on the main part of the common are inappropriate in a situation where an isolated column stands alone.

The fittings chosen in the future should be of high quality and whether modern or traditional they should be able to stand alone in design terms.

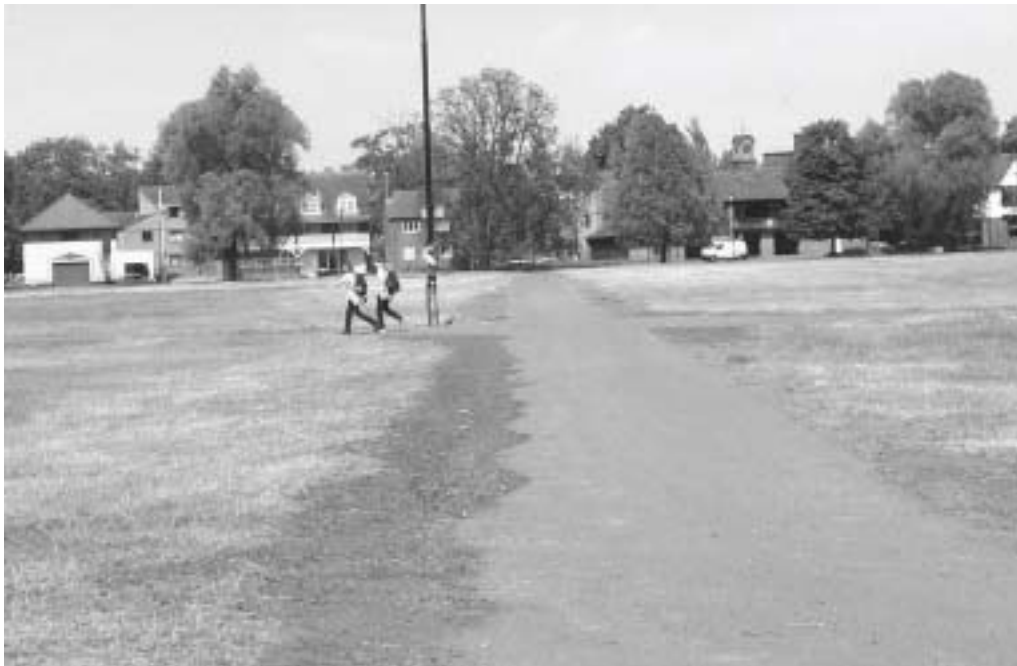
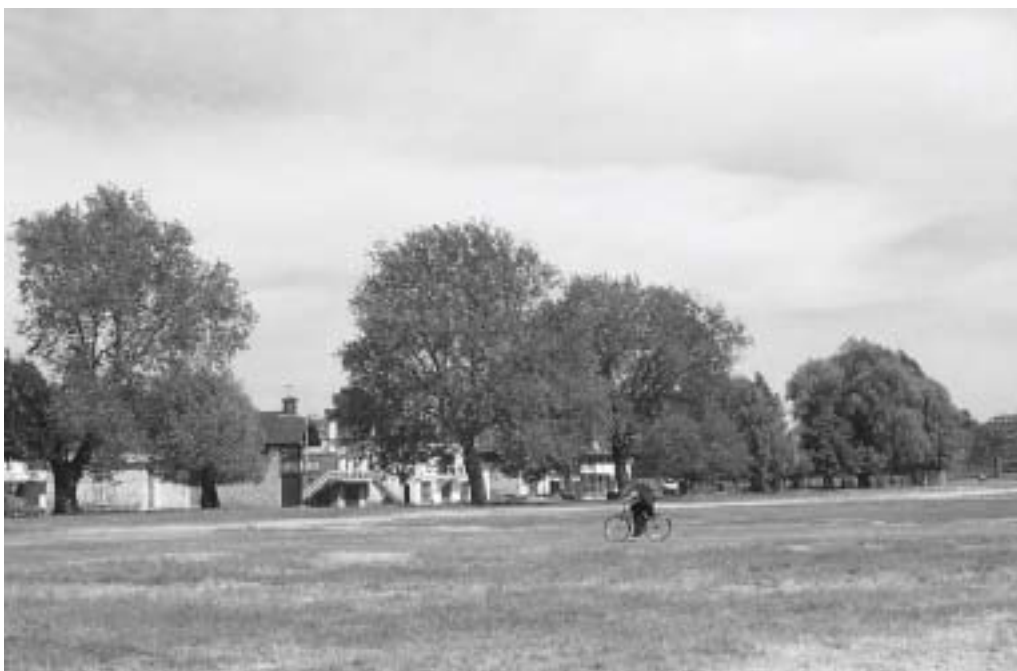
## 5. PATHS

The paths are surfaced in asphalt and are generally unobtrusive. When viewed from a distance the paths crossing the common are almost invisible. This is a suitable material for path surfacing close to the riverside poplars and willows as it is flexible and involves a shallower construction than a paved path. The surfacing material needs to be easily repaired where heavy vehicles overrun the edges.

The surface could be made more appropriate to the setting by the application of a gravel chipping topdressing emulating the appearance of a gravel path while affording the practicality of asphalt.

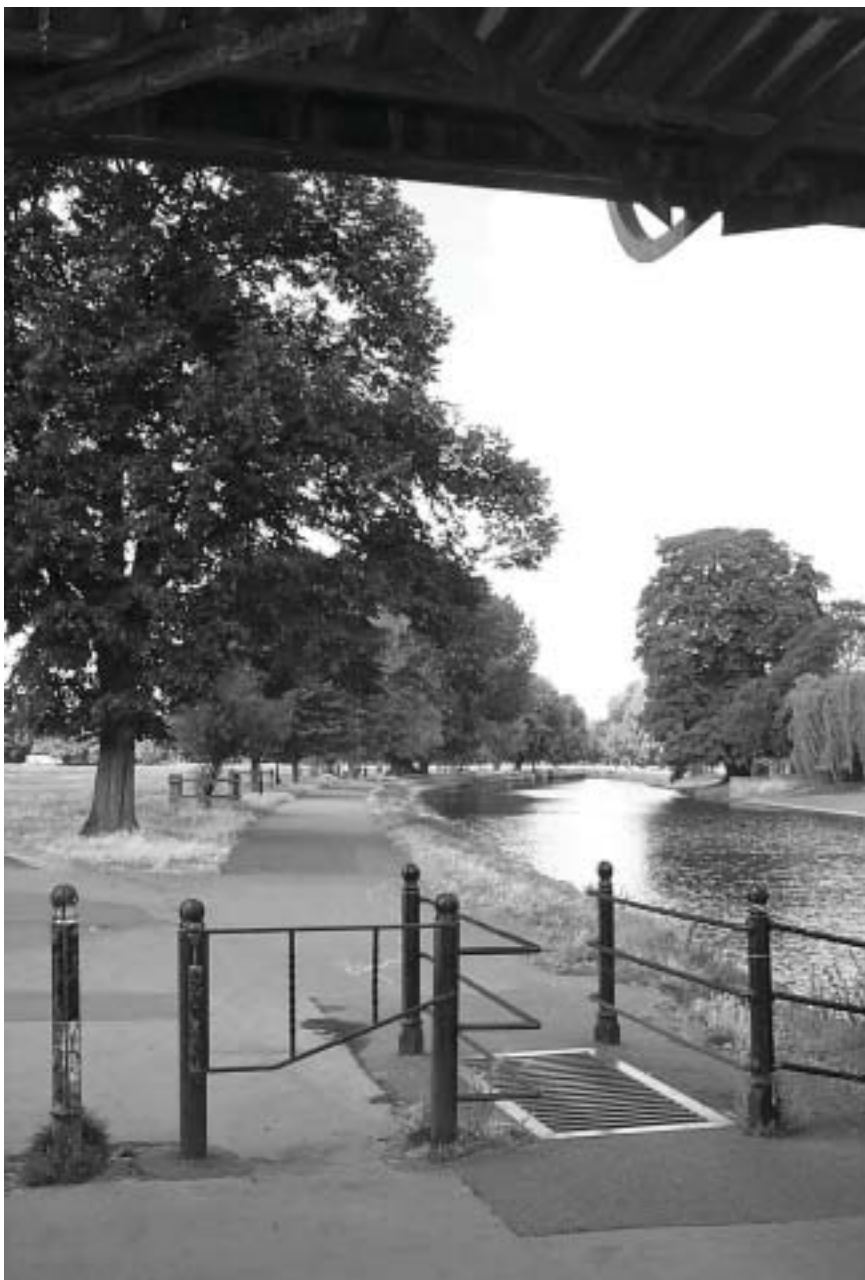
## 6. RAILINGS

The majority of the railings around Midsummer Common are black painted cast iron, three rail Cambridge bollard style. Recently pram irons have been replaced with cattle grids that make movement easier for cyclists and give better access for wheelchairs and prams. The railings along the river at the east end are a more modern style using vertical bars to discourage climbing.

The railings should continue to be coordinated in their style and colour. The riverside railings should be painted a receding rather than a pale colour to make them as inconspicuous as possible in long views.

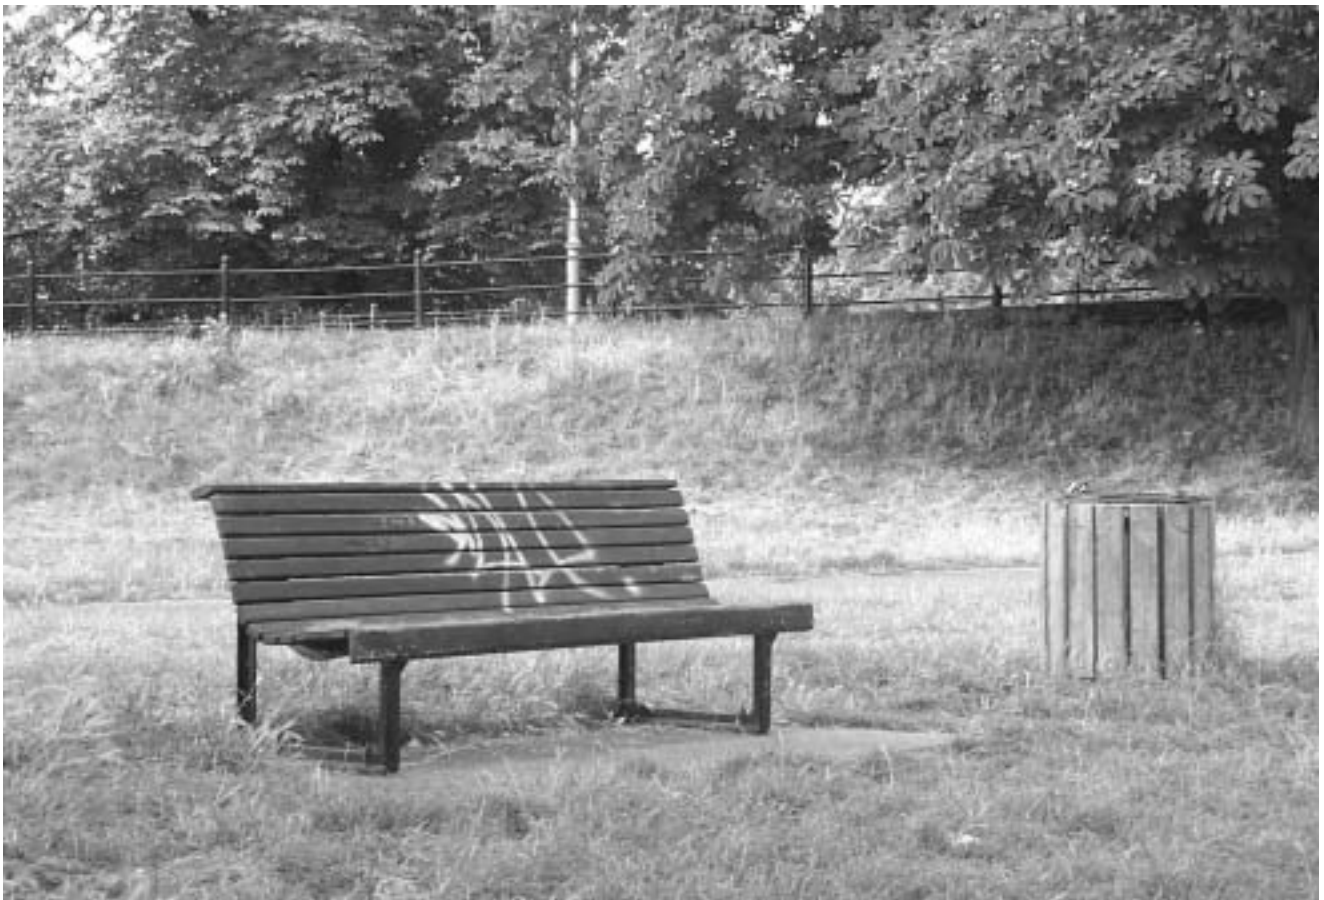
## 7. SEATS and BINS

There are 9 Wicksteed 'Huntington' seats on Midsummer Common and 17 bins of a slatted timber design.

They have no significance other than that their appearance is appropriately low key and a satisfyingly simple design that is easily repaired.

An assessment should be made as to whether more seats are required along the towpath or placed elsewhere on Midsummer Common. Users of the common could advise the City Council on this matter. They are vulnerable to vandalism and should be repaired promptly in order to avoid the creation of a run down air.

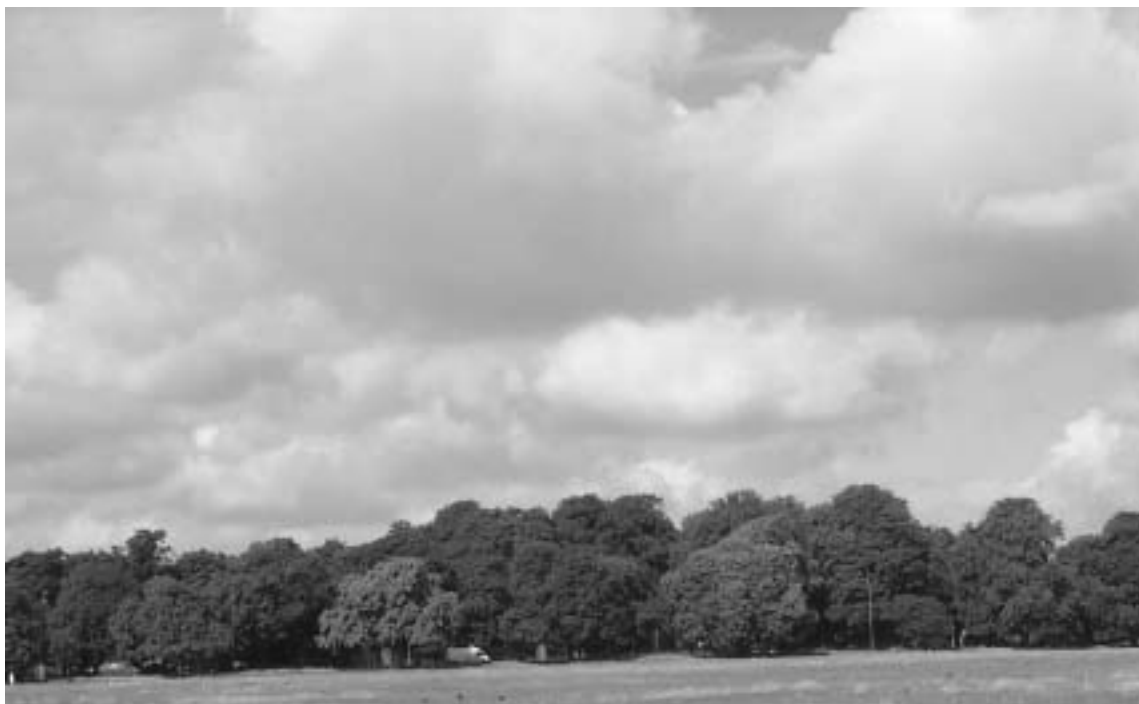
The trees were the original planting following the construction of the road and bridge in 1890. They are in mixed health and it is likely that a few will have to be heavily pruned or felled within the next few years.

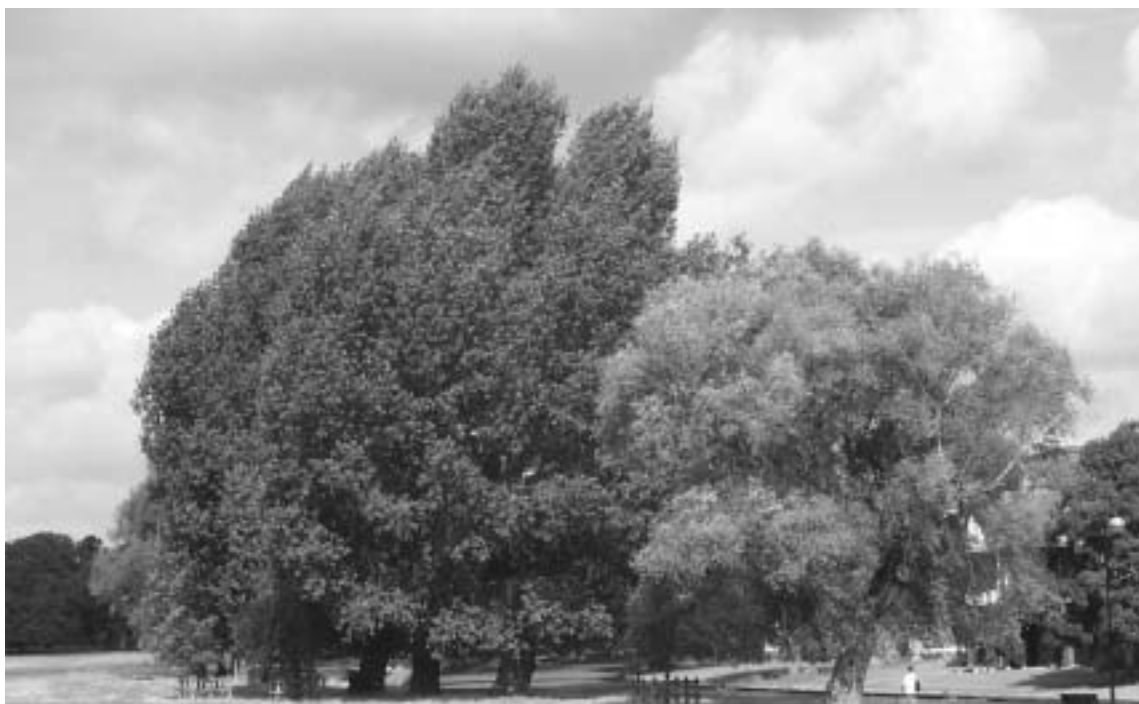
*(Towpath tree planting in summer 2001)*

The willow, poplar and London plane trees planted along the riverside emphasise the curve of the river; provide broken shade for walkers and those sitting watching the river; and integrate the various building styles of the boathouses to form the visual boundary of the north side of the common. These river frontage trees are in a poor state being either young and badly damaged, or over mature and are in need of heavy pruning to maintain safety.

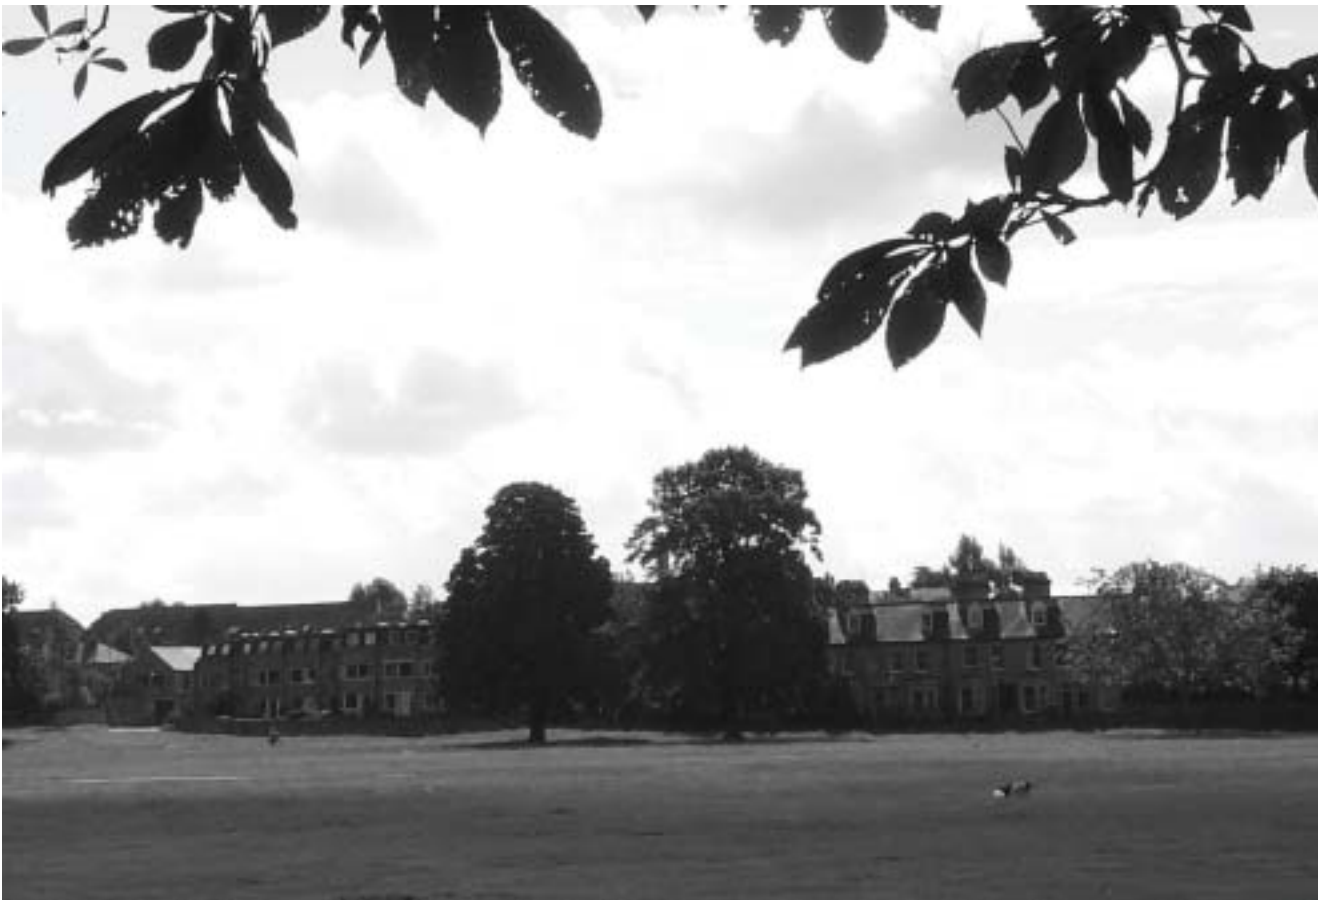
*(Perimeter trees in summer 2000)*

The two wych elms on Maids Causeway and the weeping lime along Brunswick Walk are in excellent condition. The limb structure of the group of London plane trees facing the Four Lamps roundabout is weak. The planting around the rest of the south side of the common is sparse.

An arboricultural strategy needs to be prepared for the maintenance of the existing trees and future planting to maintain a mixed aged tree stock which complements the semi natural character of the common; maintains the relationship between its residential surroundings; integrates other developments within its visual envelope and continues the important white willow habitat that runs along the River Cam from outside the city.

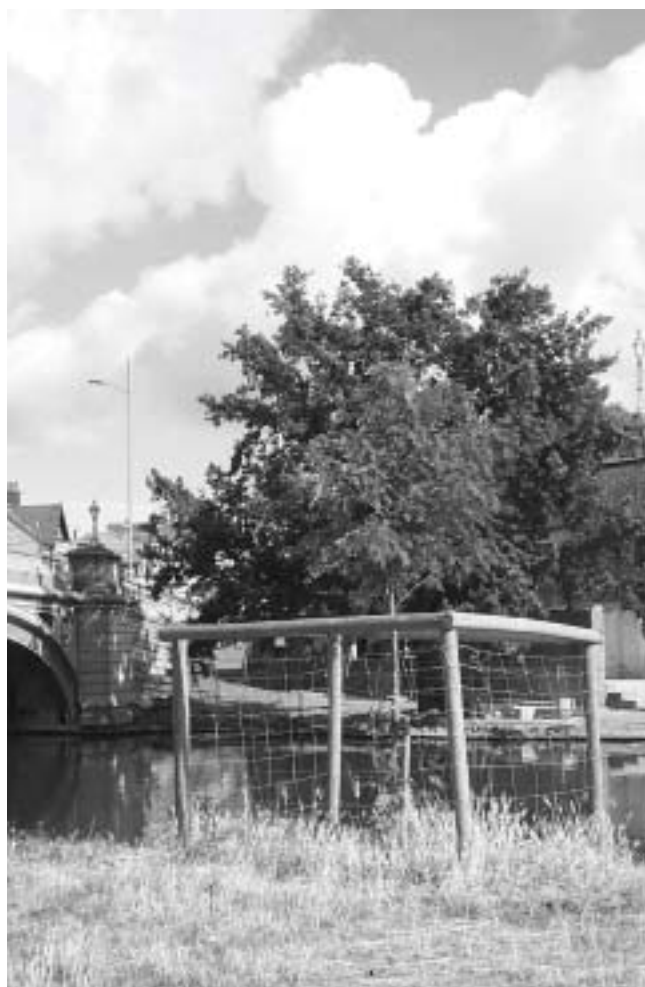
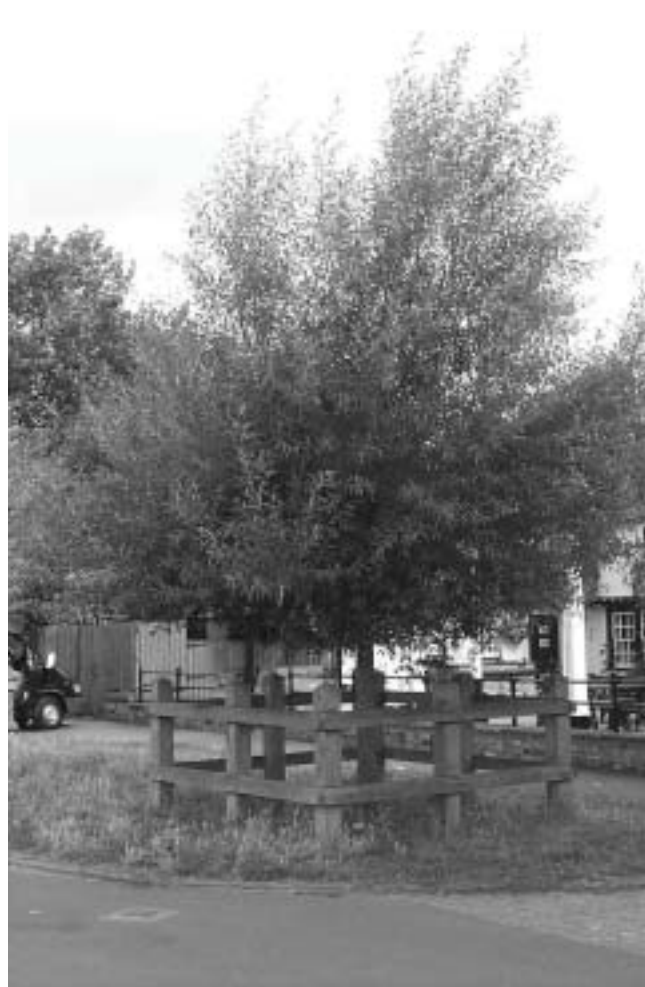
## 9. TREE GUARDS

The timber tree guards are practical in protecting the trees from the effects of cattle grazing and vehicle compaction. However a large number of them on the common could look intrusive. There are some older timber tree guards with netting that have not stood up well to vandalism and therefore create a run down air along parts of the towpath, particularly where the trees within them are also in poor condition.
